Re: Vote for Special Assessment at Adjourned Annual Meeting, December 28, 2019

Exhibit A
Lincoln Station Special Assessment
For
Clubhouse Repairs

At this year's Annual Homeowners Meeting to be held on November 9, 2019, the board will ask for a vote on a special assessment for repairs and improvements for the clubhouse. The information below is provided to provide you with background related to the repairs, estimated costs, and describe the proposed payment schedule.

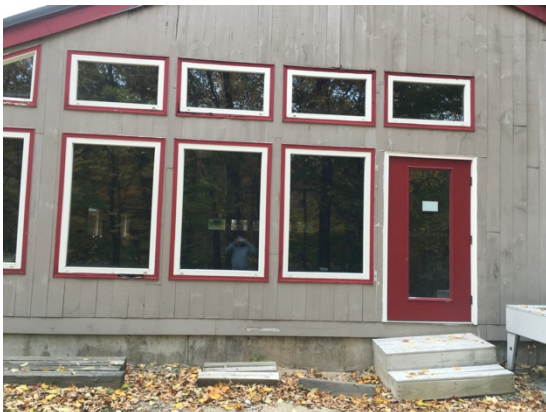
The east side (back) of the pool house is in the worst shape. The sun has caused "cupping" of the siding allowing water to get in behind the walls (Figures 1-3.). There are also several windowsills that are rotted and will need to be replaced (Figure 4).

Figure 1. Replace East Wall - Add 1" Insulation.

The repair work here will be to replace the entire east wall siding, replace the existing underlayer insulation with one-inch foam board and add an eave above this wall. Currently there is no eave and rain water is allowed to directly hit the side of the building.

The stairs exiting the building on the East side will also be replaced as well (Figure 1).

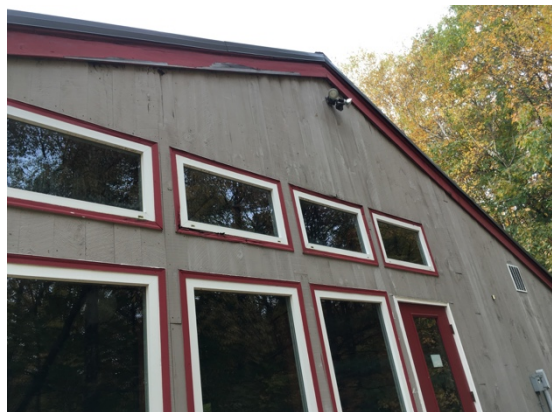
Figure 2. East Wall - Add Eave.

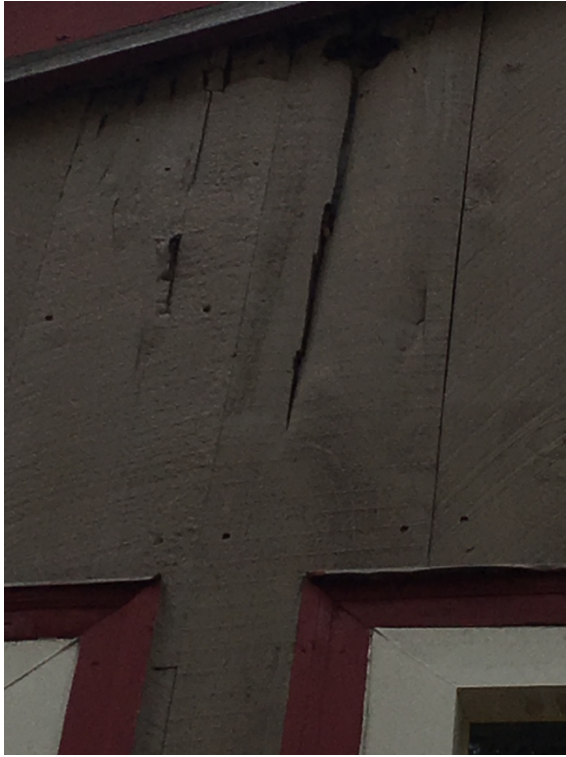
The clubhouse is due to be painted in 2020. As always, prior to painting any of the buildings, we repair rot on damaged siding. The exterior of the pool house building has several areas that are in pretty bad shape. The wear on the pool house walls is compounded by the humidity from inside the building working its way through the inside walls.

Figure 3. East Wall - Rain & Humidity Damage.

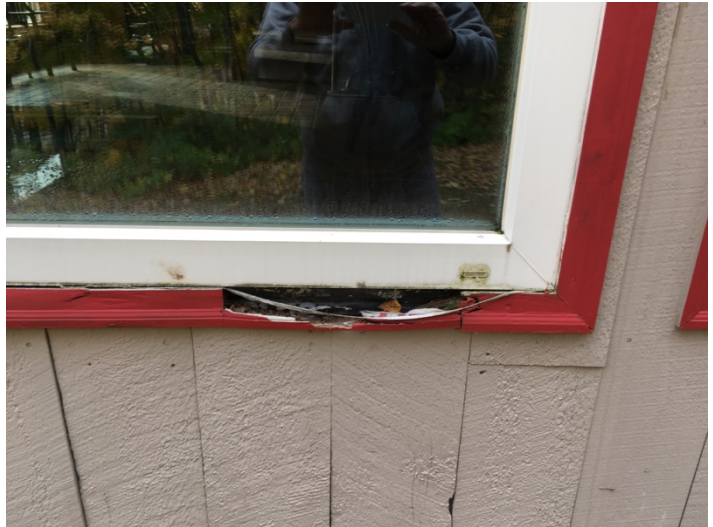
Figure 4. East Wall - Replace Window Sills.

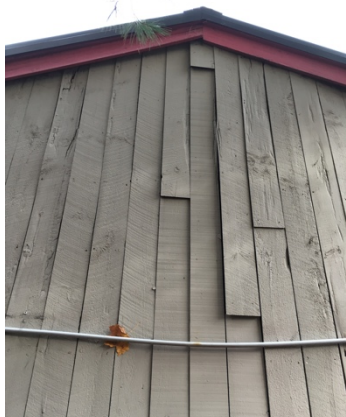
The west side of the wall is in better shape, but still needs some work. On this side we plan to replace about 20% of the siding, replace a few rotted window sills, and add the eave. We don't plan to replace the insulation underneath (Figures 5-6).

Figure 5. West Wall - Replace 20% of Siding & Add Eave.

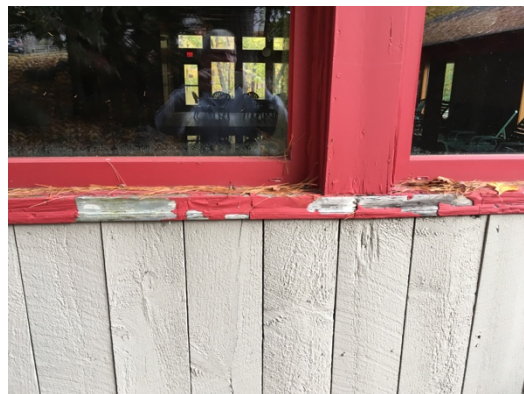
Figure 6. West Wall - Replace Window Sills.

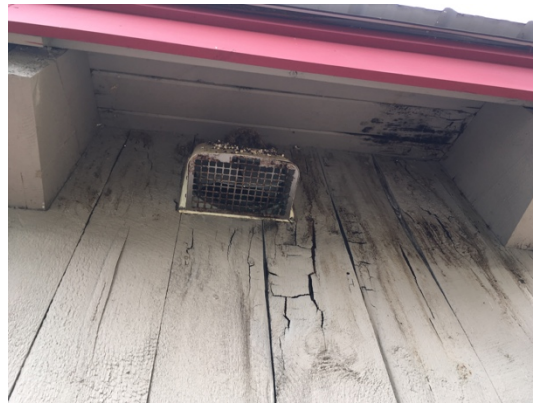
There is an area on the north side of the wall where the exhaust fan is located that will require the siding to be replaced and the eave repaired (Figure 7). As the humidity exiting from the pool house is the reason for the damage, we will also be replacing the fan and rerouting the air flow to keep it away from the building.

Figure 7. North Side - Repair Exhaust Fan Damage.

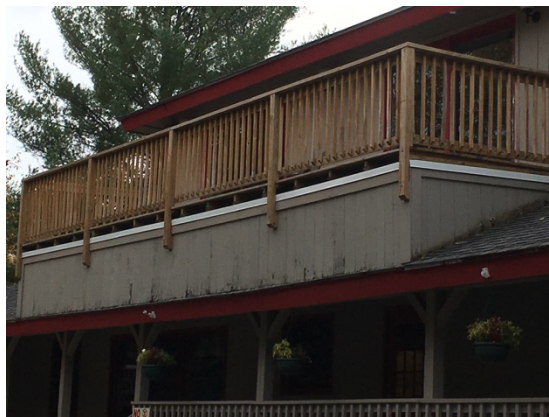
The siding around the apartments deck on the second level will also be replaced as it is sun damaged and rotted (Figure 8).

Figure 8. Replace Siding on Apartment Deck.

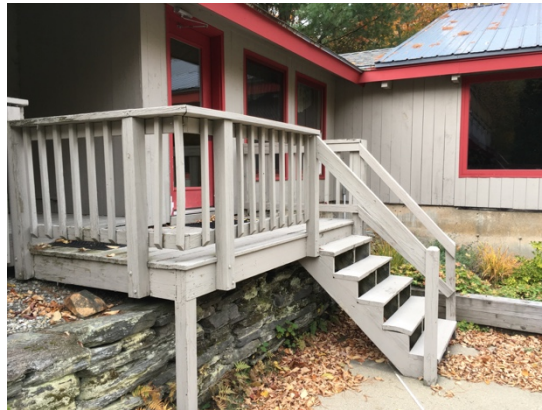
On the east side of the building, where the exit door from the indoor pool opens to the outdoor pool area, the small back deck and stairs will be replaced (Figure 9). The wood is quite weathered with signs of rot, and the railings and railing posts are all loose (partly due to rotting wood)

Figure 9. Replace Small Back Deck and Stairs.

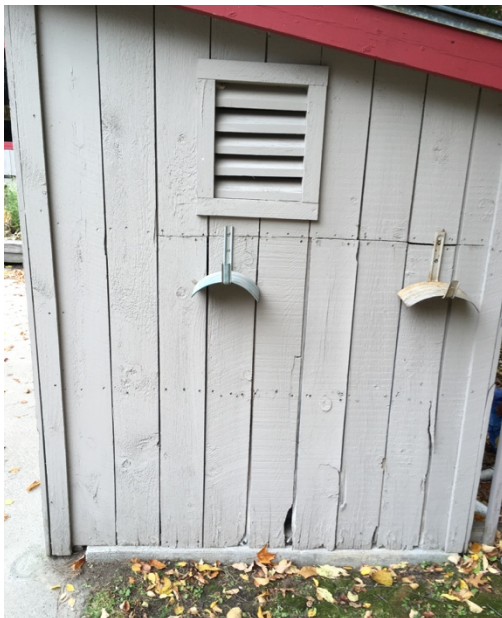
The Pool Equipment Shed houses the pump, electrical, and water distribution system equipment for the outdoor pool. All walls of the shed are in different levels of disrepair with significant wood rot particularly around the bottom edge (Figure 9 & 10).

Figure 9. Replace Pool Shed Siding (1).

The shed has no insulation or inside walls so the repair would be to remove the old siding and replace it using the existing shed frame. A shelter will also be built over the pool heater to prevent weather related damage.

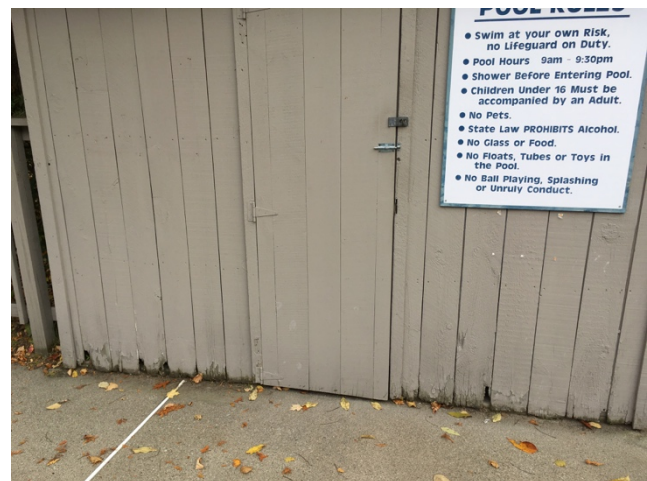
Figure 10. Replace Pool Shed Siding (2).

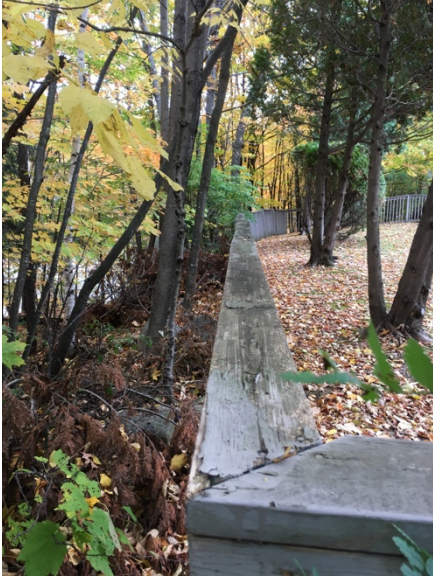
The existing fence has a significant number of areas with extensive rot. Over the past several years we've repaired various sections and loose, or missing, balusters. Some of the posts are also loose. See Figures 12 & 13.

Figure 12. Replace Outdoor Pool Fence.

There are a number of trees along the fence line that lean over or are right next to the fence (Figure 12). The shade from some of these trees is responsible for the fence rotting away. These trees will be removed to prevent potential damage to the new fence in the future, and to facilitate the installation of the fence.

We will remove the existing wooden fence and replace it with a new six foot high, black metal fence as shown in Figures 14.

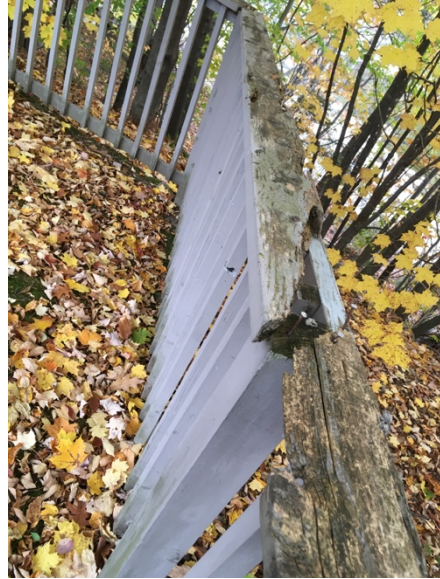
Figure 13. Rotted Fence Sections.

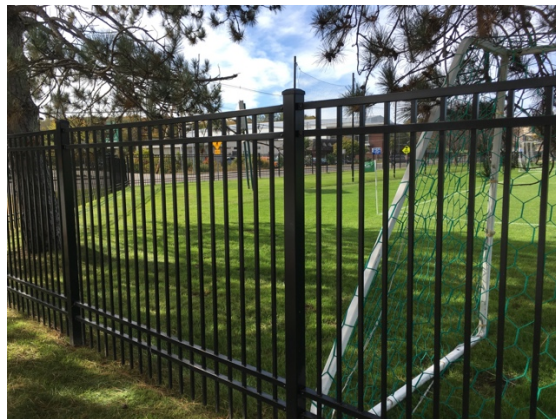
Figure 14. Proposed New Fence.

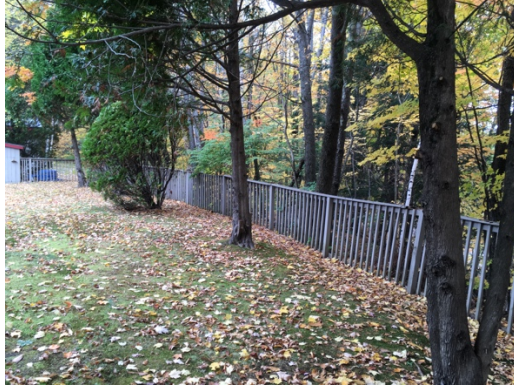
Figure 15. Tree Removal Inside Pool Area Fence.

The grassy area between the pool and the fence has eroded away and is covered mainly with moss. This area would be leveled off and sod installed (Figure 15).

The cypress trees inside the fenced area will also be removed to open up this area and allow in the sunlight for the grass to grow, and to allow the area to be used for other recreational activities (Figure 15).
